## **Analysis of the causes of the crash of Flight MH17 (Malaysian Boeing 777)**

### **1. The Event**

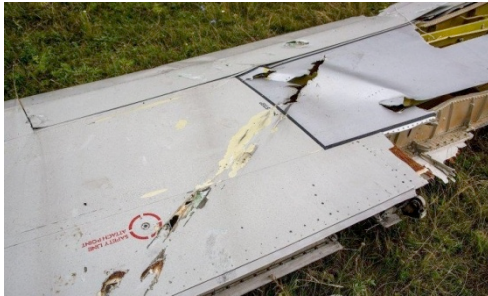
**Picture 1. Fragment of the Boeing 777 plane**  
**Фото 1. Фрагмент плоскости Boeing 777**

A detailed analysis of its fragments can provide a more complete picture of the causes of the crash. In reviewing the photos of the plane fragments presented on the Internet, you can see the different forms of damage to its shell or skin – tears and fractures, holes with folds on the

outer and the inner sides of the fuselage, tell-tale signs of a powerful external impact on the plane.

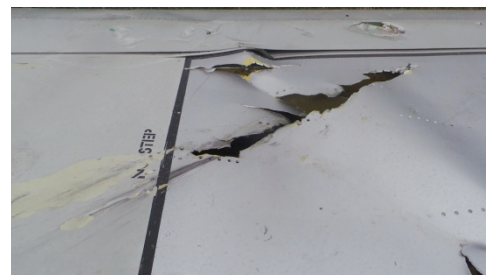
**Picture 4. Detail of the Boeing 777 plane**  
**Фото 4. Фрагмент плоскости Boeing 777**

Of particular note are the holes folded inward in the fuselage. They are round-bored, and usually grouped. Such holes can only be formed by metal objects with a circular cross-section, possibly rods or shells from an aircraft gun. The question arises: who could deliver such projectiles to the aircraft, by what means, and what might they look like?

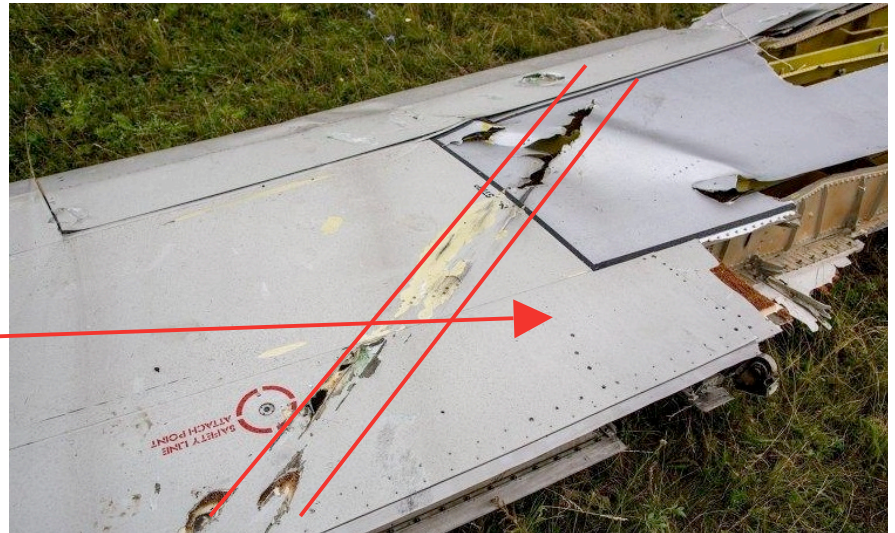
If we consider the first version of the crash, it is evident from the way the holes are arranged in the fragments of the flat surfaces and the fuselage that they do not reflect the typical picture of the impact of "Buk-M1" missiles, which would have left a very noticeable and characteristic pattern of damage marks. In this case, it is clear that there are no such traces on the debris fragments.

It would be logical to assume that the damage shown in photo 19 is more commonly associated with aircraft cannon shells of the GSH or SPPU type.

Damage to the Boeing 777 is not characteristic of the SAM "BUK-M1" missile

Photo 19. Damage to the flat surfaces of the Boeing 777  
 Фото 19. Повреждения плоскости Boeing 777

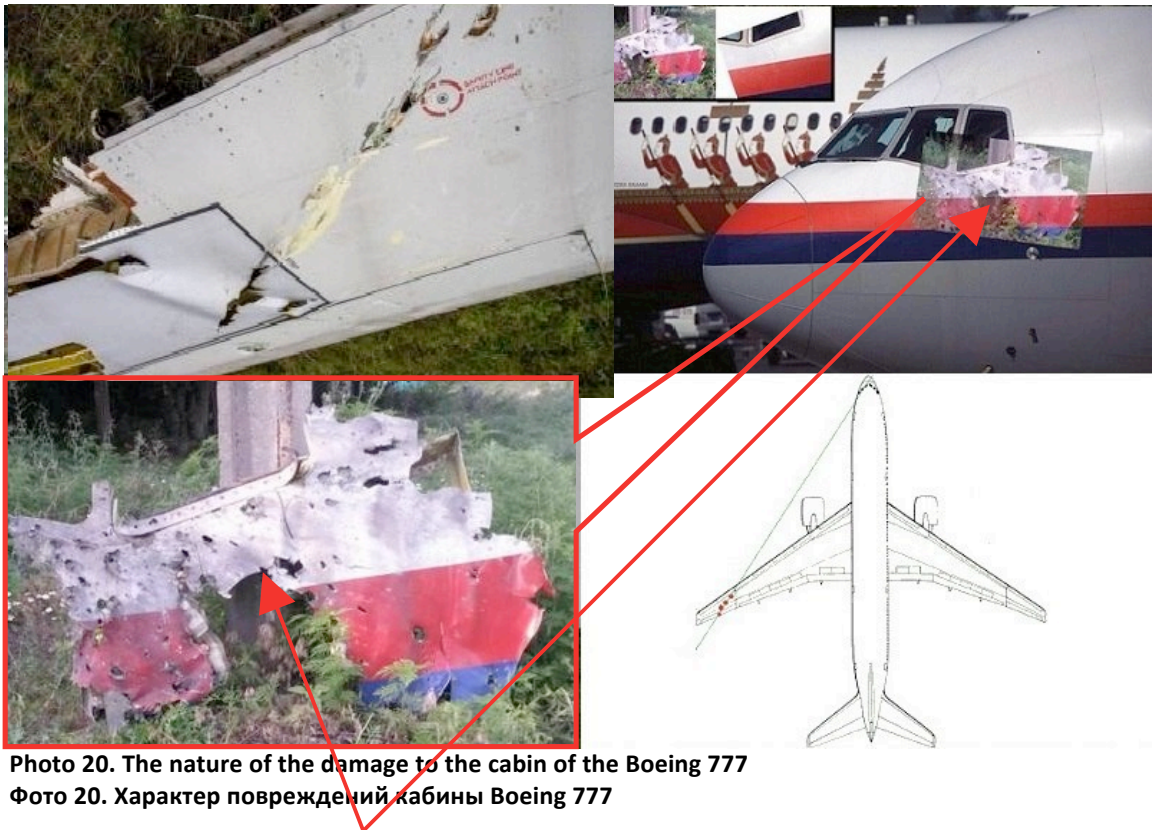
Photo 20. The nature of the damage to the cabin of the Boeing 777  
 Фото 20. Характер повреждений кабины Boeing 777

The picture of the entry and exit holes in the cockpit of the Boeing 777 are fully consistent with the passage through the flight of shells from the 20-30 mm caliber guns found on military aircraft. This confirms the second version of what brought down the Boeing. This is further supported by the way the puncture holes are dispersed along the surface of the aircraft. The edges of the fragment of the fuselage from the left side of the cockpit are folded from the inside outward, which indicates that a significant blast occurred within the cockpit as a result of the dynamic impact of the shells on the right side. On the trim panel the characteristic entry holes are visible as well as some exit points. The edges of the holes are bent inward; they are much smaller and are circular in shape. The exit openings are less clearly formed; their edges are torn outward. In addition, it is clear that exit holes broke through double aluminum lining and tilted it outward. That is, the strike elements ([judging] by type of impact - aircraft cannon shells) punched right through the cockpit. The open rivets were also bent outward.

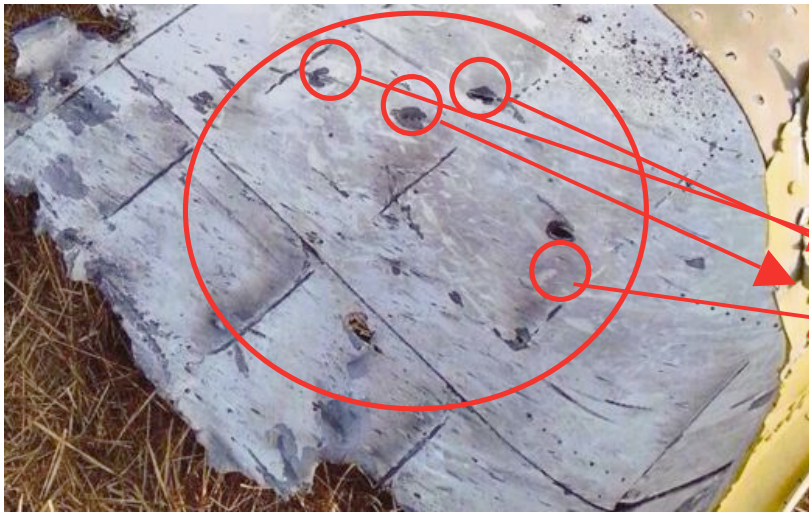
**Photo 21. nature of the damage skin Boeing 777**  
**Фото 21. Характер повреждений обшивки Boeing 777**

A fragment of the Boeing 777. Clearly seen are the entry holes in the outer layer, folded inward, caused by a 30-mm gun. The inward folds are clearly seen, which are characteristic of this type of projectile.

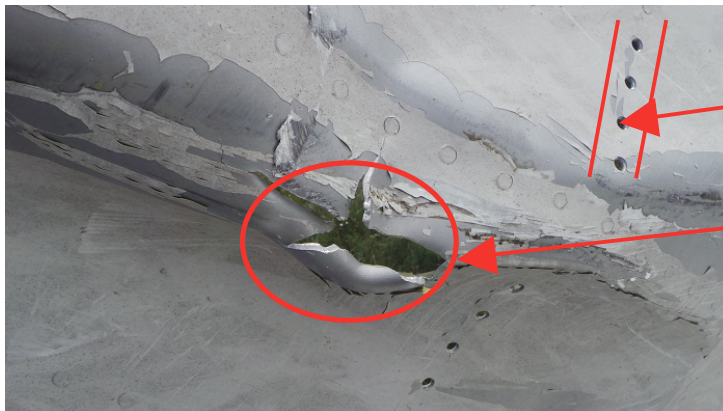
**Photo 22. nature of the damage skin Boeing 777**  
**Фото 22. Характер повреждений обшивки Boeing 777**

Fragment of Boeing 777.  
Taken off the rivet.

Rupture of the fuselage from the inside to the outside edges of the impact blow that is caused by any explosion inside the airplane, or a sharp drop in internal pressure at high altitude
